# **SPAN/CHRYSLER RESEARCH SAFETY VEHICLE PHASE III FINAL TECHNICAL REPORT**

## **Volume I: Executive Summary**

| 4. Title and Subtitle<br>CALSPAN/CHRYSLER RESEARCH SAFETY VEHICLE<br>PHASE III FINAL TECHNICAL REPORT<br>VOLUME I, EXECUTIVE SUMMARY | | | | 5. Report Date<br>April 1980 | |

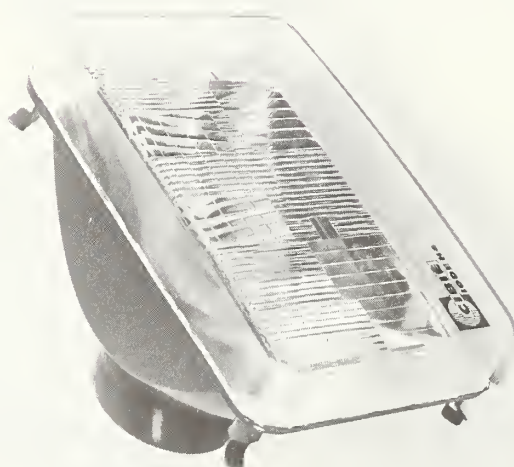
**Figure 20 RSV PLASTIC HEADLAMP**

RSV headlamps (Figure 20) have only one beam and use a plastic lens to attain precise aiming for improved lighting with reduced glare while effecting a weight savings (Figures 21 and 22). While not fully developed, this system could have safety advantages by providing better lighting, and eliminating improper beam usage. A suspension activated hydraulic headlamp aiming system is available to automatically compensate for vehicle loading and dynamic effects. High-level rear lamps are located on the rear roof pillars (Figure 23). They combine running, side-marker, stop, and turn functions in a highly visible location.

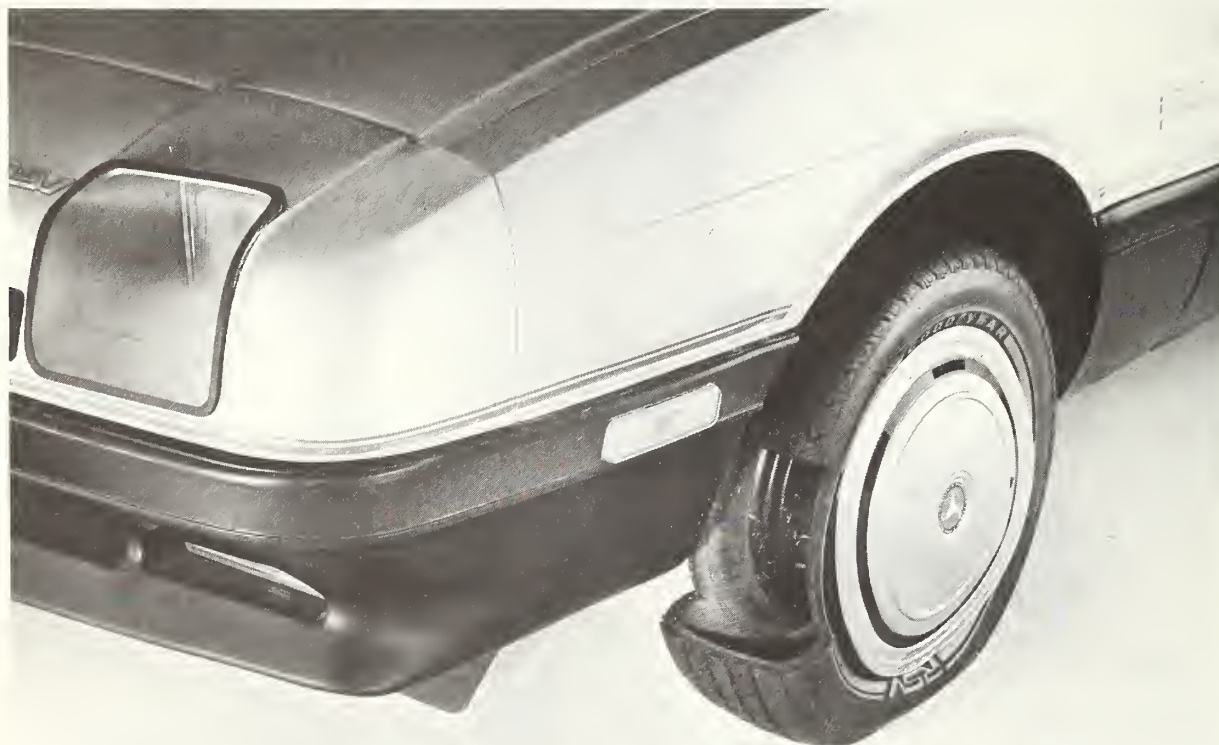
**Figure 30. Flatproof Tire**

The tire system utilizes a flatproof tire (Figure 30). When the pressure is removed, the thicker sidewalls support the car weight and car handling response is not severely affected. A low tire pressure warning system

is included to provide an instrument panel indication when any of the four tires has less than 115 kilopascals (17 psi). The car can be driven up to 65 km (40 miles) at speeds up to 65 kph (40 mph) to a service station without damaging the tire, providing added safety by eliminating the hazards of roadside tire changing. There is also a small weight savings (albeit at added cost) afforded by replacing five tires and the jack with four flatproof tires even though they weigh more individually than the standard ones. A substantial increase in luggage volume is also achieved.
